## CONTINUING ELIGIBILITY INSPECTION (CEI) REPORT

FOR FLOOD CONTROL WORKS  
Honolulu Engineer District  
CEPOH-EC-T

1. Project Name: Kaneohe - Kailua FCP and Allied Purposes Project
2. Date of Inspection: November 5 & 8, 2007
3. Inspection Personnel:

4. Ratings for FY08  
Project Rating: "MS, Marginally Satisfactory"  
Project Condition Code: "MA, Minimally Acceptable"  
Project Status: "Active"

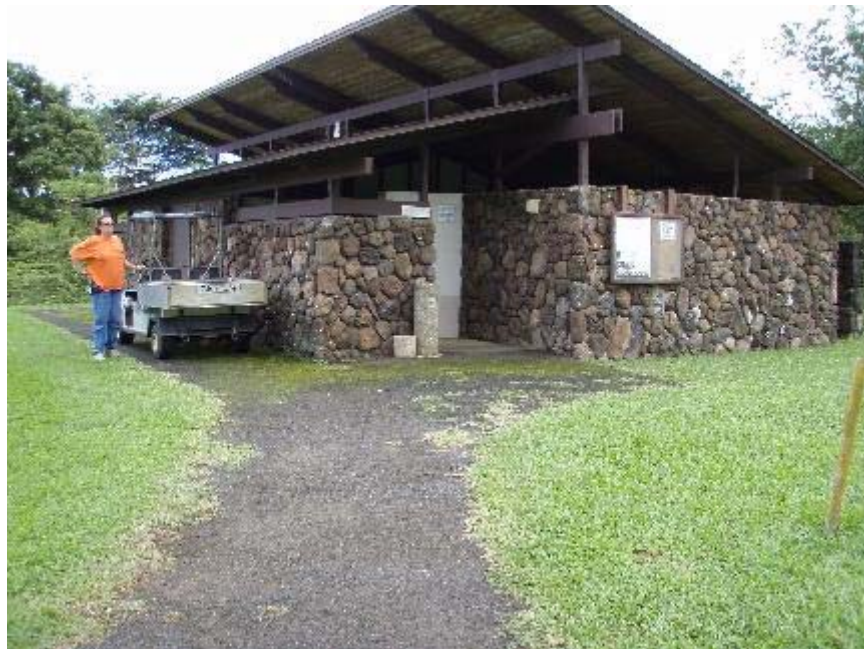
b. Kahua Nui Area Restroom (makai) repair sidewalk, restrooms in good condition.

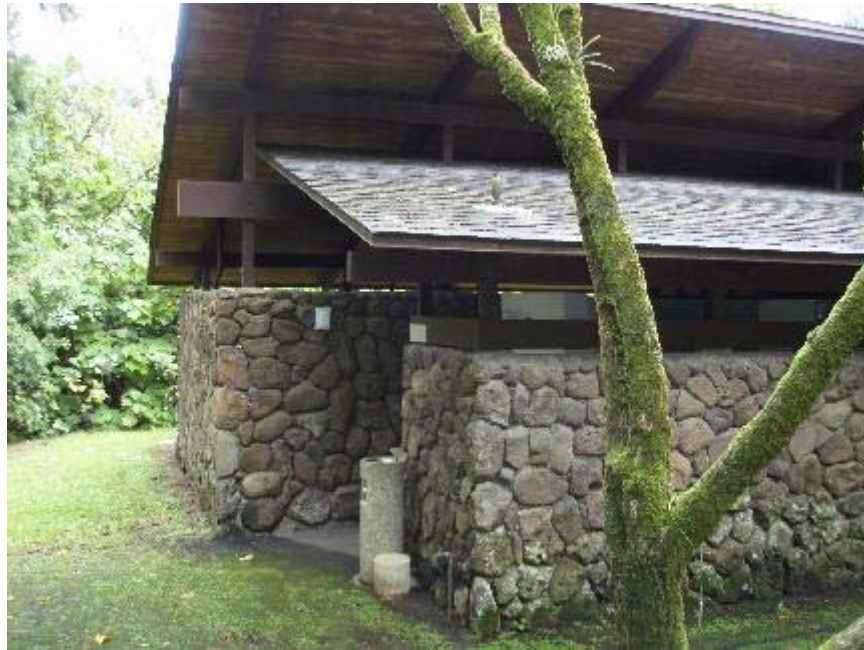
c. Kahua Hau Area Restroom in good condition.

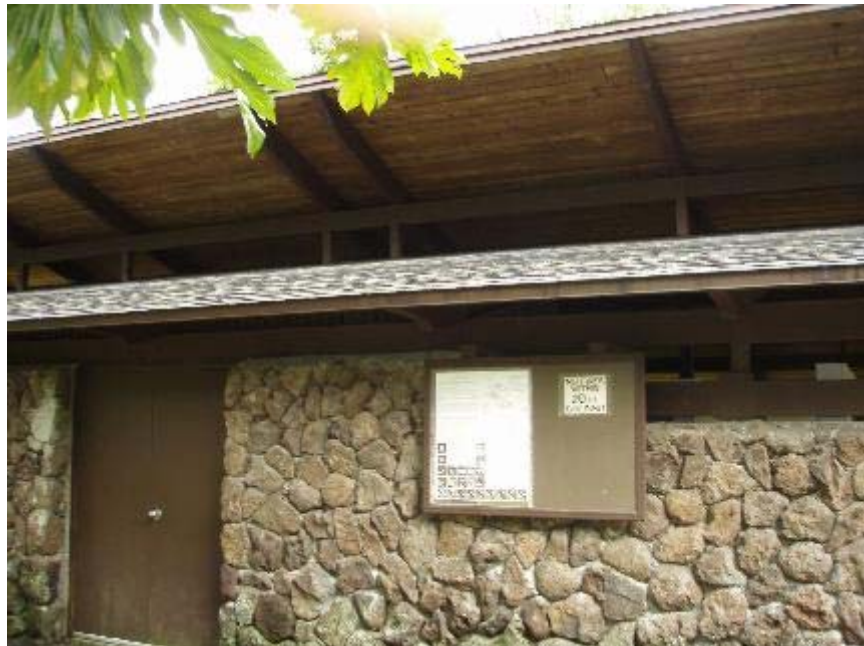
d. Kahua Kukui Area Restroom, in good condition.

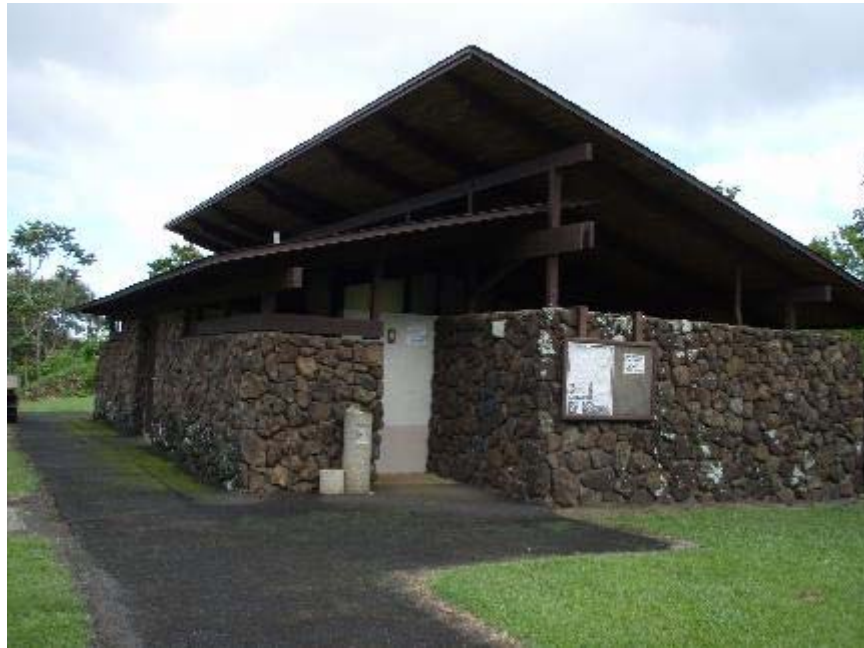
e. Kahua Lehua Area Restroom, fix water fountain on men's side.

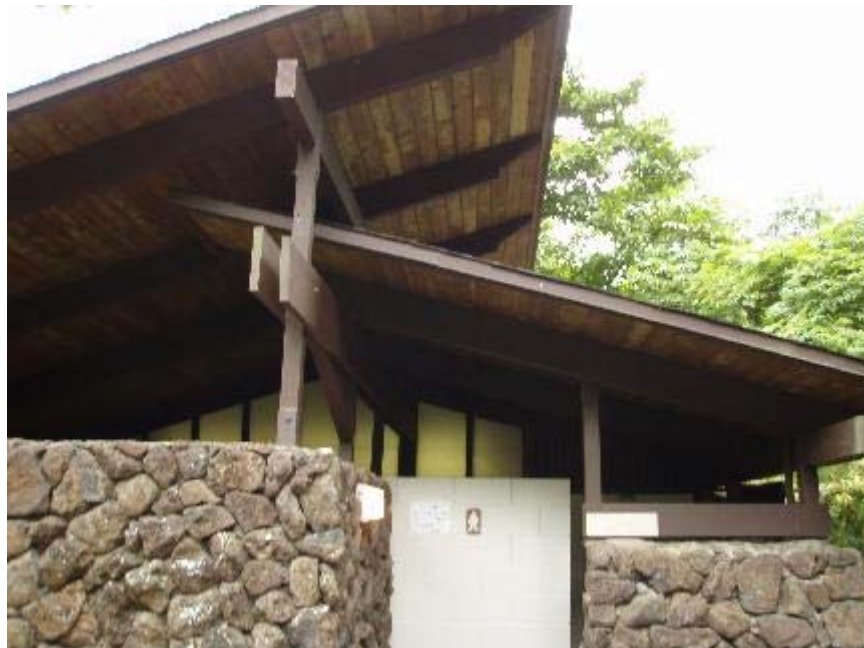
f. Kahau Kuou # 1 Restroom, in good condition.

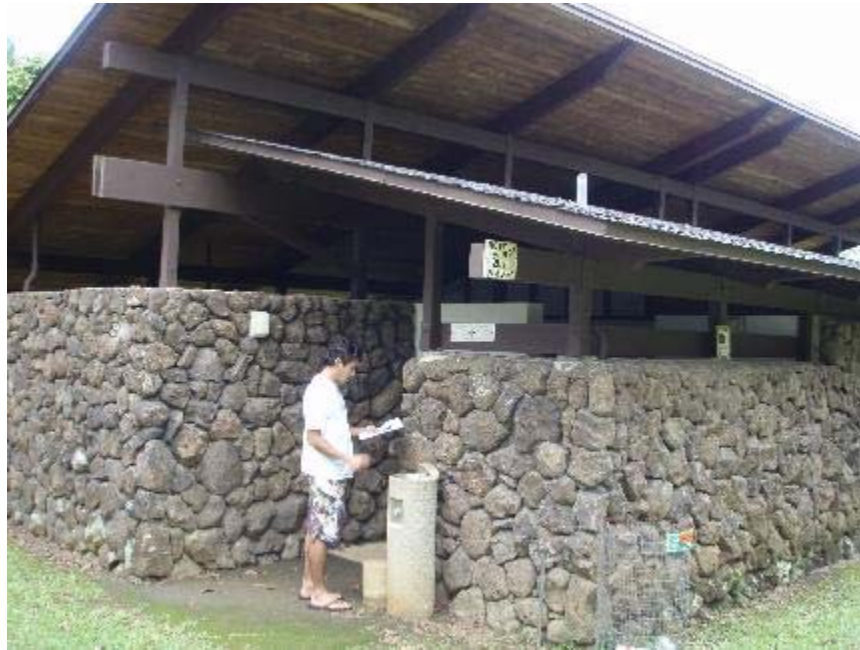
g. Kahau Kuou #2, restroom in good condition.

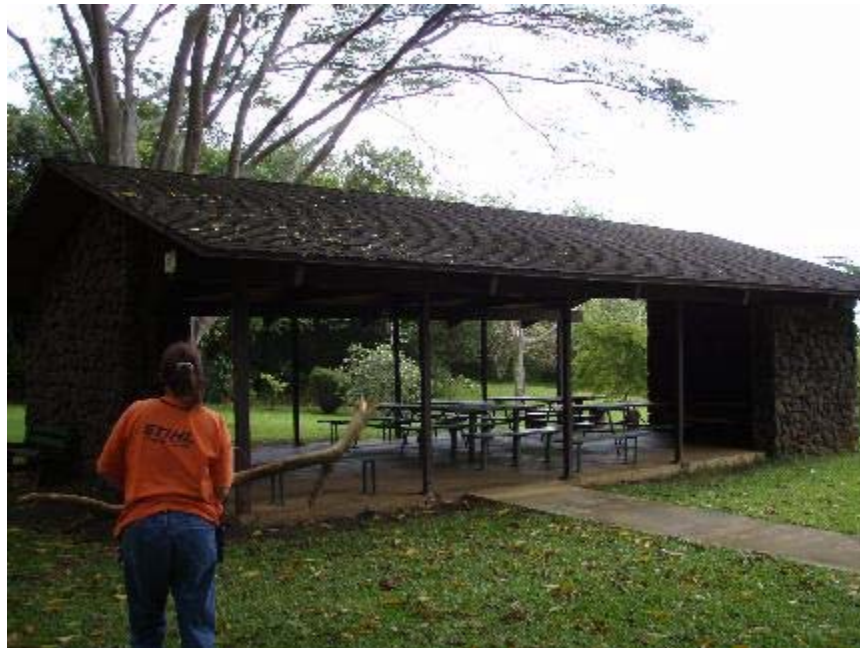
h. Day Use Area, replace light fixtures with florescent light bulbs.

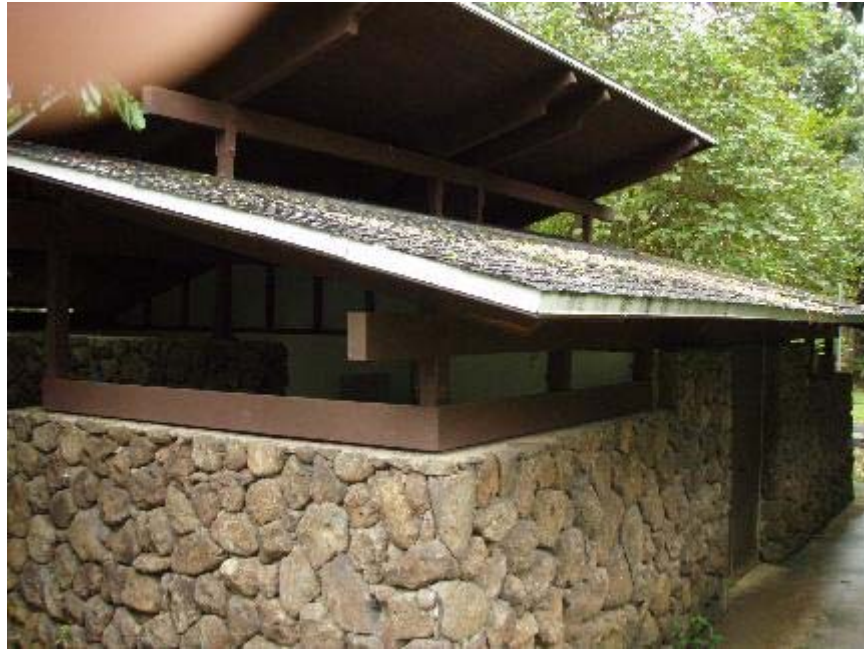
- i. Day Use Restrooms, in good condition.

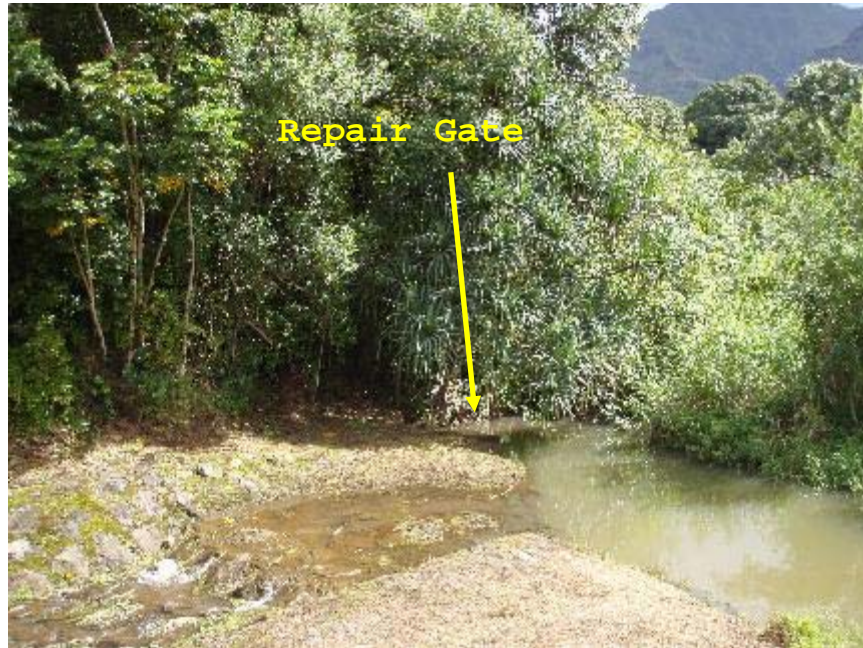
- a. Sluice gate inoperable, repair gate.

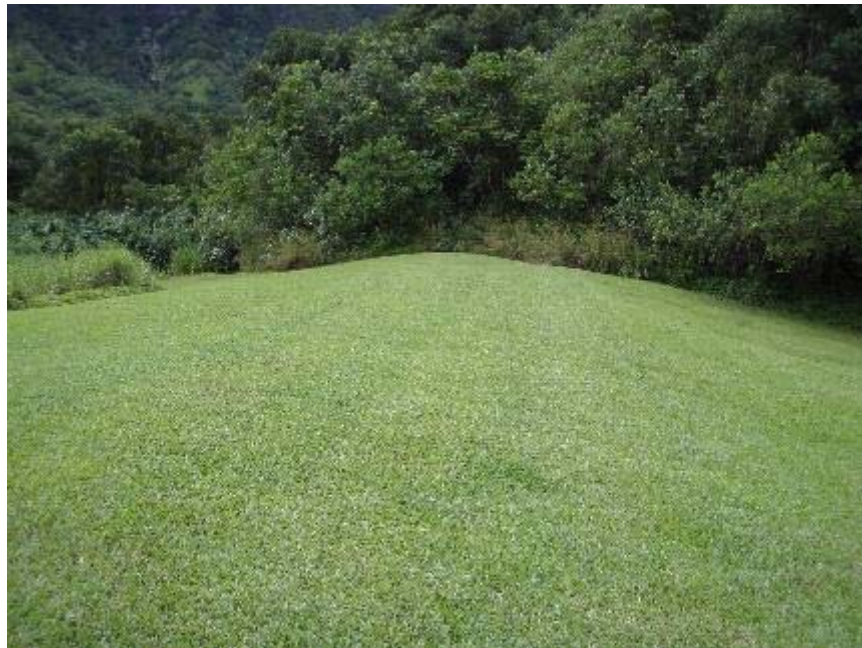
- b. Mitigation area levee, continue to maintain.
